Risk Governance for Procurement in Future Fuels – Interim Report 1

Project number: RP2.3-06

Risk Governance for Procurement in Future Fuels

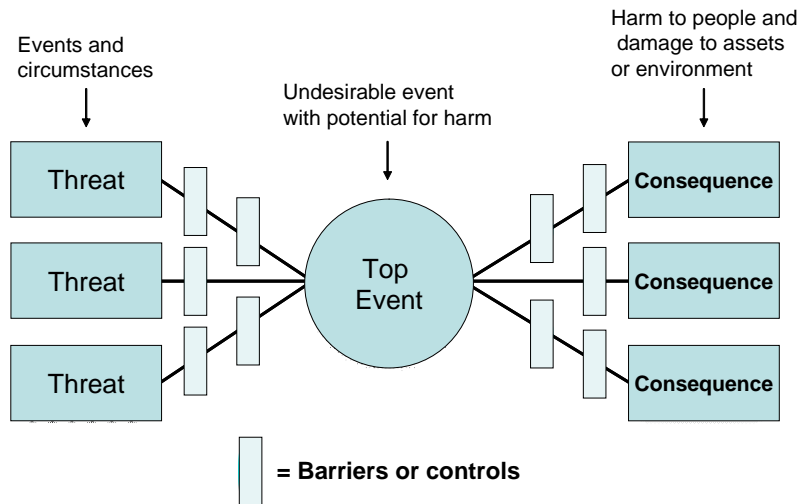
Figure 2. Generic Bow Tie Diagram³

While Reason’s model was developed with physical disasters in mind, this type of thinking about failure applies equally to other types of objectives such as meeting schedule and cost in a project environment. The aspect of Reason’s model that is of relevance for this stage of the research project is the ‘holes’ in the Swiss cheese that represents vulnerabilities of the system. Moving further into risk the management process, we also adopt the elements of the Bowtie model (Figure 2) as a theoretical framework for this project. A bow tie is a diagrammatic representation of a specific hazardous event (“Top event”), the causes and consequences of the event, plus all the controls in place to prevent, mitigate and recover from the event (“Barriers of controls”) (Bice & Hayes, 2009). The threats or events/conditions that potentially cause the Top Event along with the current risk controls (or reduction measures) are identified first. The consequences of the Top Event which are possible outcomes that could occur are also realised. Once the consequences are developed, the next step is to identify recovery measures that can stop, limit or recover from the impact arising from the Top Event. In this report, known procurement risks, associated failures and potential consequences are analysed and at the later stage of the project, we will move further into understanding barriers of controls to reduce the risk of failure.
